1854 Ansei Nankai Earthquake Tsunami Hit ‘The Water Metropolis of Osaka’. Monument Warns of the Next Nankai Earthquake Tsunami.

Takeshi Nagao¹

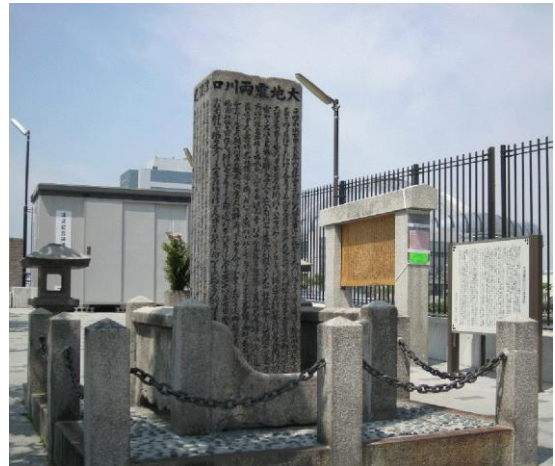
Photo 1. The memorial of the Ansei Nankai earthquake tsunami .

There is a stone memorial about 2.0 m tall, inscribed with many characters, on the north side of the east end of Taisho Bridge in Naniwa Ward, Osaka City(Fig. 1). This memorial is called ‘Daijishin Ryo Kawaguchi Tsunamiki’ (‘The Record of the Great Earthquakes and the Tsunami at the Mouths of the Two Rivers’) (Photo 1). It was constructed, not only to commemorate the victims of the 1854 Ansei Nankai earthquake tsunami, but also to warn the Citizens of Osaka City the next Nankai earthquake tsunami.

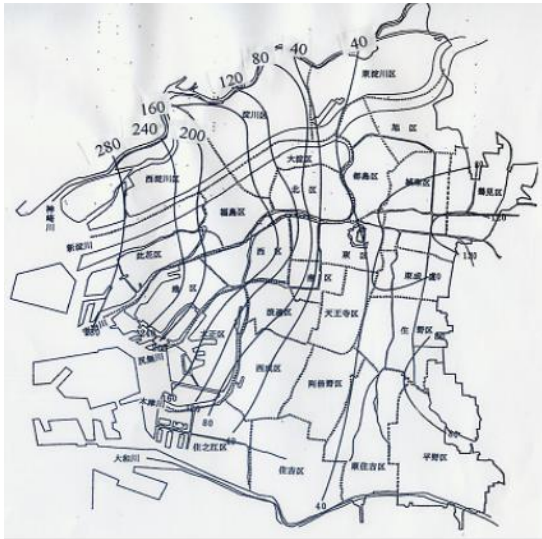
Fig. 2 Cumulative land subsidence in Osaka City. (1935 ~1981) Based on "The General Situation of Subsidence in Osaka", published by the Conference of Synthesis Measures Against Subsidence in Osaka, 1983. Units of cumulative subsidence are in cm.

In modern times the Osaka Bay area has been developing, and the lowland area has become densely populated. What is worse, land subsidence, caused by heavy reliance on ground water, continued for several decades. It is most serious in western Osaka City where the maximum recorded subsidence is about 3.0 meters (Fig. 2). Today in Osaka City, the area of ground height below sea level is 21 square kilometers(Fig. 3). If a tsunami ever hits Osaka again, we must run for higher ground.
